NBSIR 82-2510

Quality of Inspections Utilizing Infrared Technology on Weatherization Retrofit Installations

November 1982

**QUALITY OF INSPECTIONS UTILIZING
INFRARED TECHNOLOGY ON
WEATHERIZATION RETROFIT
INSTALLATIONS**

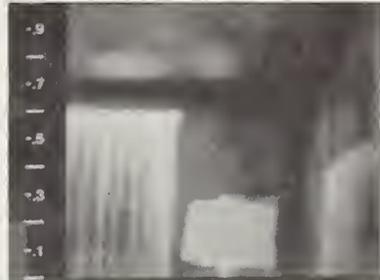
1-3
SW corner on S
of living room.
(by NBS)

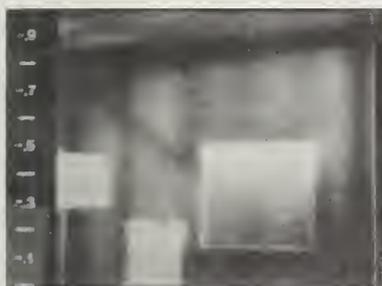
1-4
W corner on W
of living room.
(by NBS)

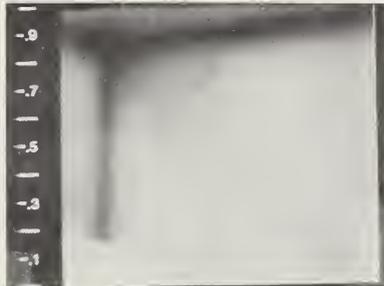
1-5
SW corner on W
of living room.
(by contractor #3)

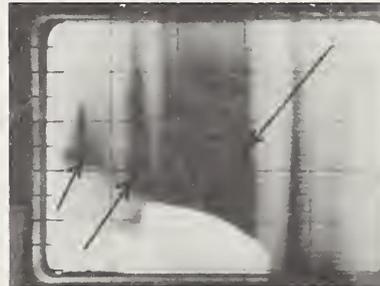
1-6
'Hollow' side door
scanned at overcast.
(by contractor #3)

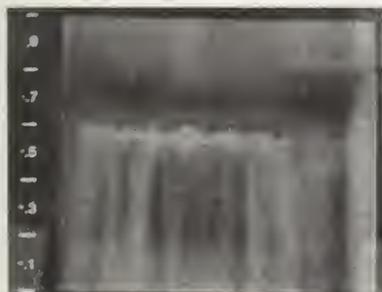
1-7
Above window & at
ceiling of bathroom.
(by NBS)

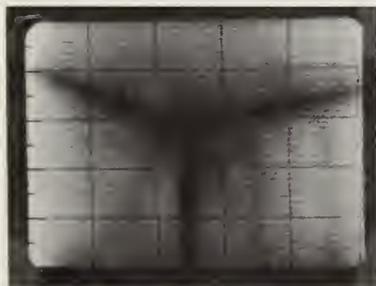
1-10
SE corner of
SE bedroom.
(by contractor #2)

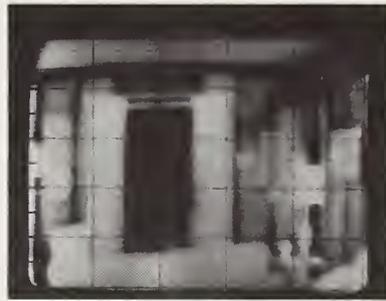
4-2
N wall of living room.
(Different density levels
of insulation by contractor #2)

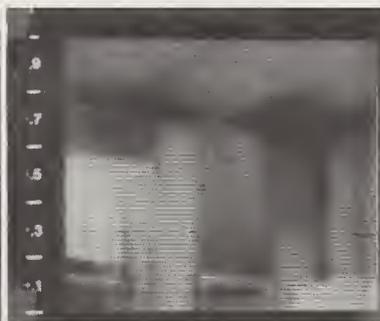
4-7
NW corner on W
of bedroom.
(by NBS)

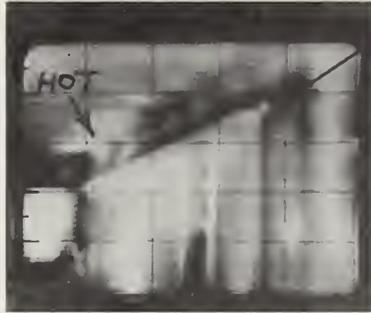
5-2
S wall of
living room.
(by contractor #2)

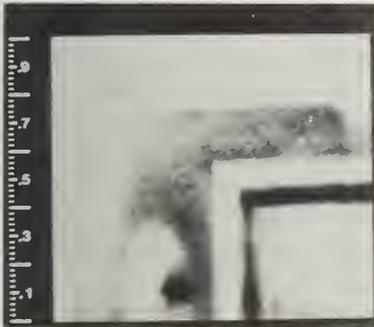
5-4
N wall of
dining room.
(by contractor #4)

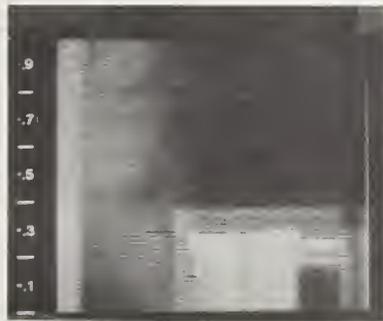
5-5
W of stairway
on 2nd floor.
(by NBS)

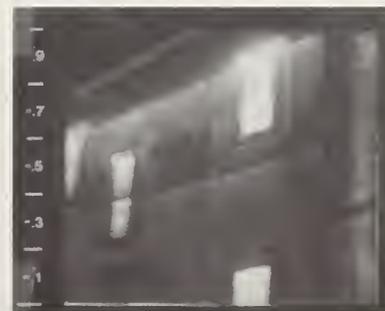
5-9
W wall of
SW bedroom.
(exterior by NBS)

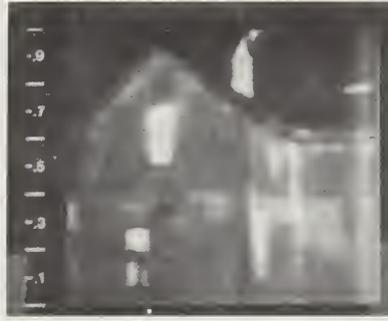
6-2
N side of kitchen
& N bedroom.
(exterior by NBS)

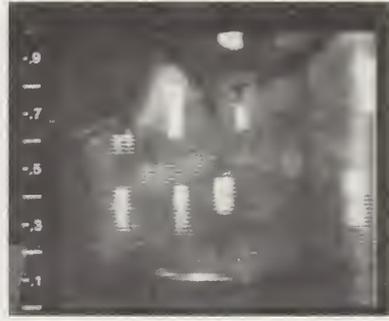
6-3
E side of family
room & bathroom.
(exterior by NBS)

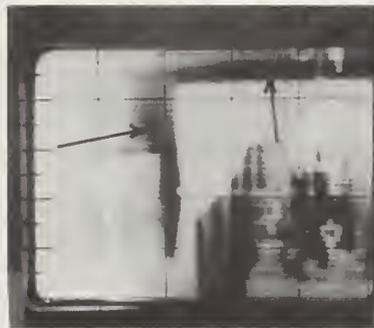
6-5
SW corner on W
of dining room.
(by contractor #2)

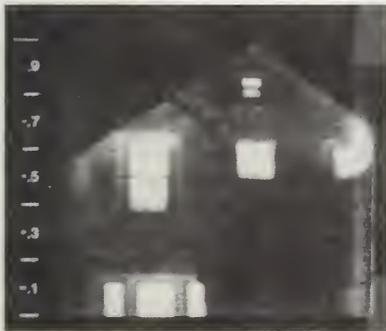
6-12
S side of sewing
room & S bedroom.
(exterior by NBS)

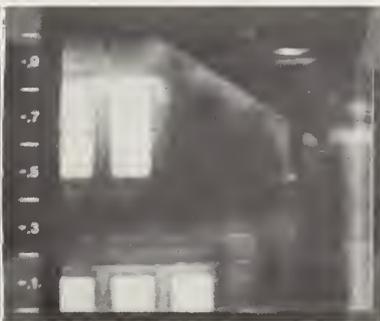
6-15
W side of W
bedroom.
(exterior by NBS)

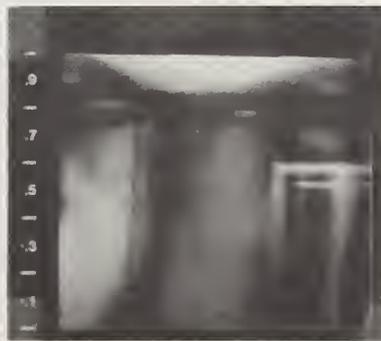
7-6
N wall of
den/kitchen
(by NBS)

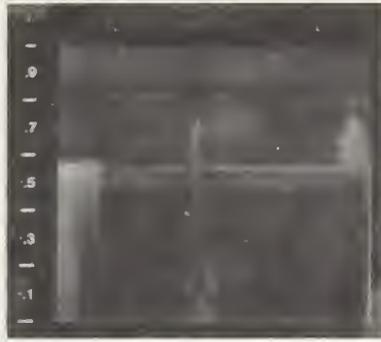
8-2
Above window on
E wall of dining room
(by NBS)

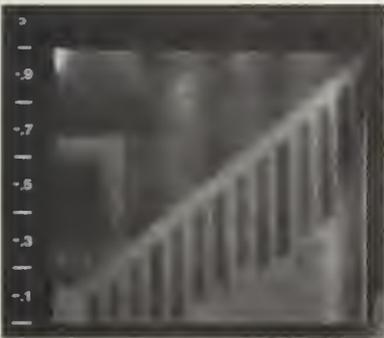
8-4
W wall & stairway
of living room.
(by NBS)

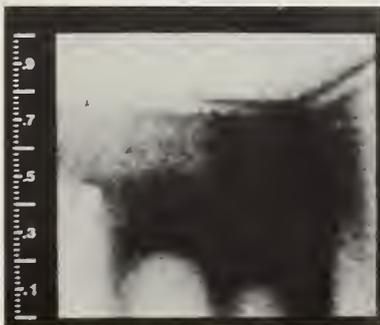
8-7
NE corner on N
of NE bedroom.
(by contractor #4)

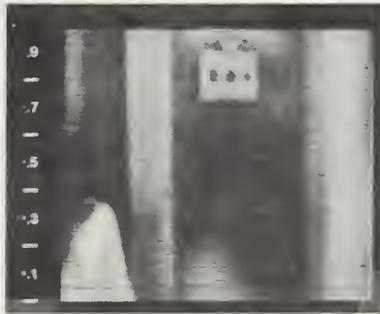
9-2
SW corner of
S entrance.
(by NBS)

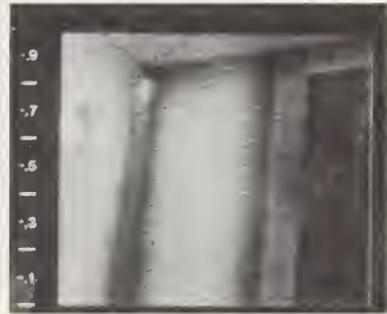
9-3
SE corner of
S entrance.
(by NBS)

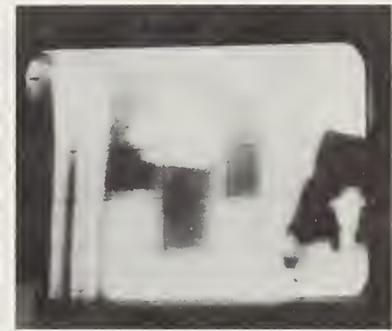
9-6
W wall of
living room.
(by contractor #6)

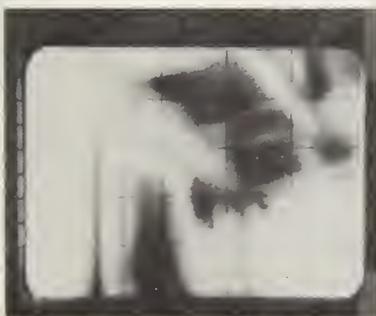
9-7
Bottom of stairway
on N of 1st floor.
(by contractor #5)

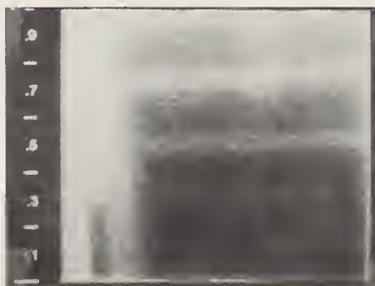
9-8
Over stairway
on N of 2nd floor.
(by NBS)

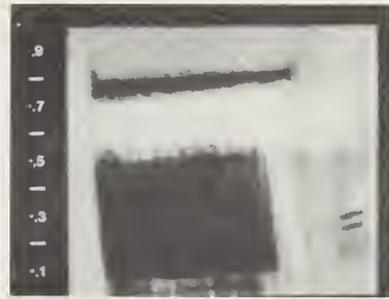
9-11
Above window
on S of bathroom.
(by NBS)

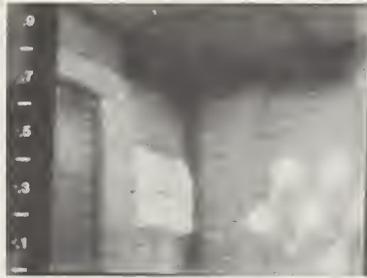
10-2

SE corner of kitchen (by NBS)

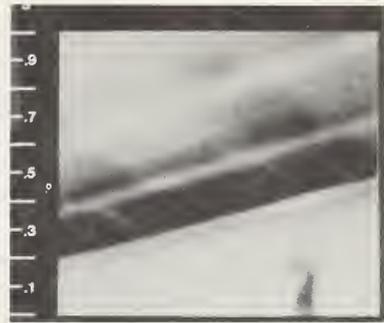
10-3

Ceiling on N side dining room. (by contractor #6)

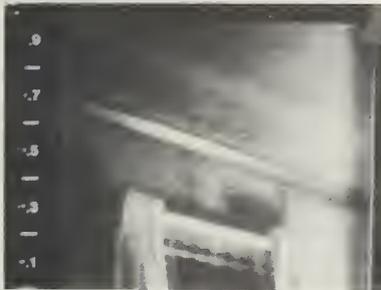
10-4

Above window on S of dining room. (by NBS)

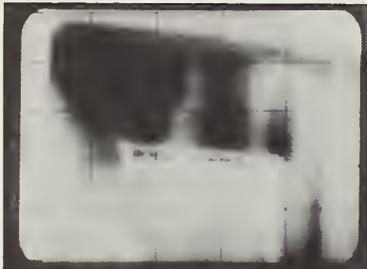
10-7

W wall of hallway on 2nd floor. (by contractor #5)

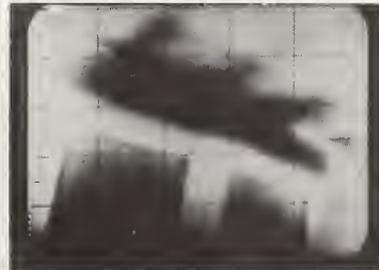
10-8

N wall of hallway on 2nd floor. (by contractor #5)

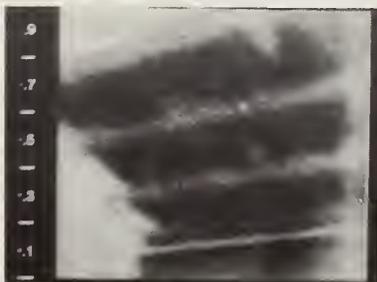
10-9

S pitched ceiling of E bedroom (by NBS)

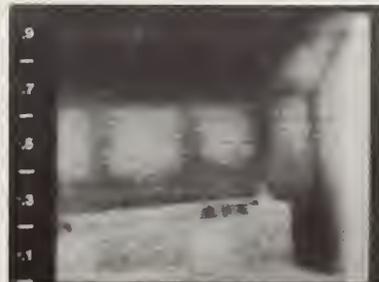
10-10

S side of W bedroom. (by NBS)

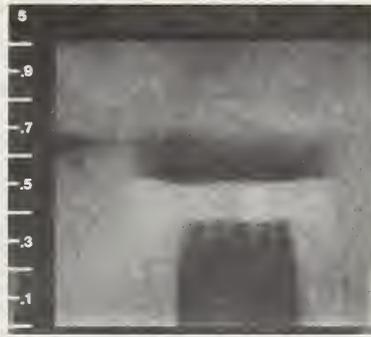
11-2
Above window on
E of living room.
(by contractor #6)

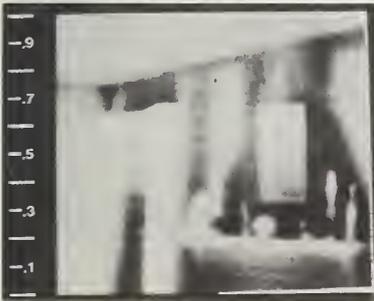
11-4
S wall of
living room.
(by NBS)

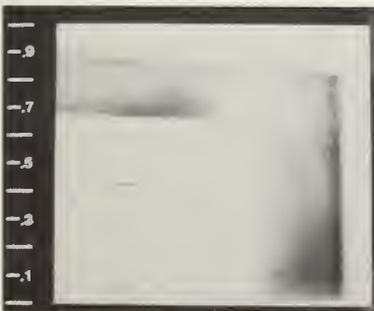
11-7
SW corner on
S of dining room.
(by NBS)

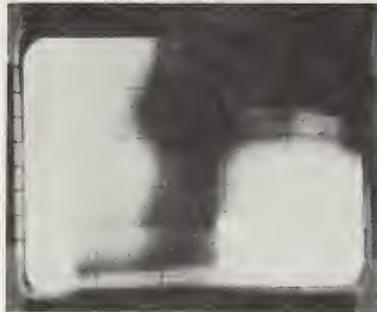
11-11
Inside closet on
W of NW bedroom.
(by contractor #5)

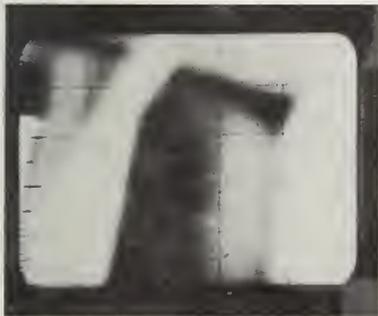
11-13
Tub area on N
of bathroom.
(by contractor #5)

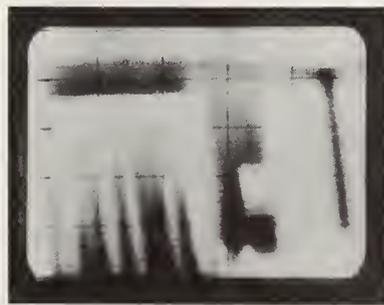
11-16
NE corner on N
of NE bedroom.
(by contractor #5)
